REPORT OF EXAMINATION

Rod Slappy-Sutton and Jean Sutton v Speedway, LLC

Keith A. Bergman, P.E.

June 16, 2017

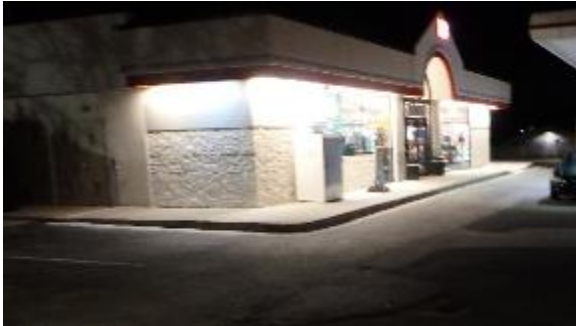
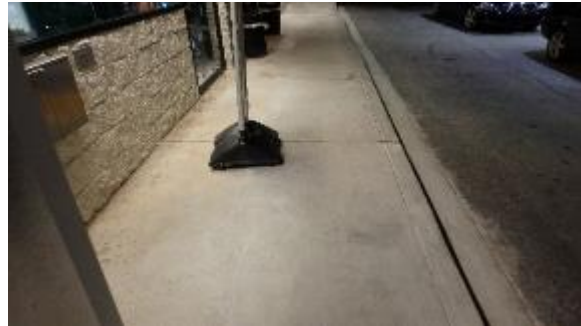
The front of the Speedway store included a concrete sidewalk area, as shown in the photographs below.

The sidewalk area included a curb which required patrons to step up onto the curb when entering the store and step down from the curb when leaving.

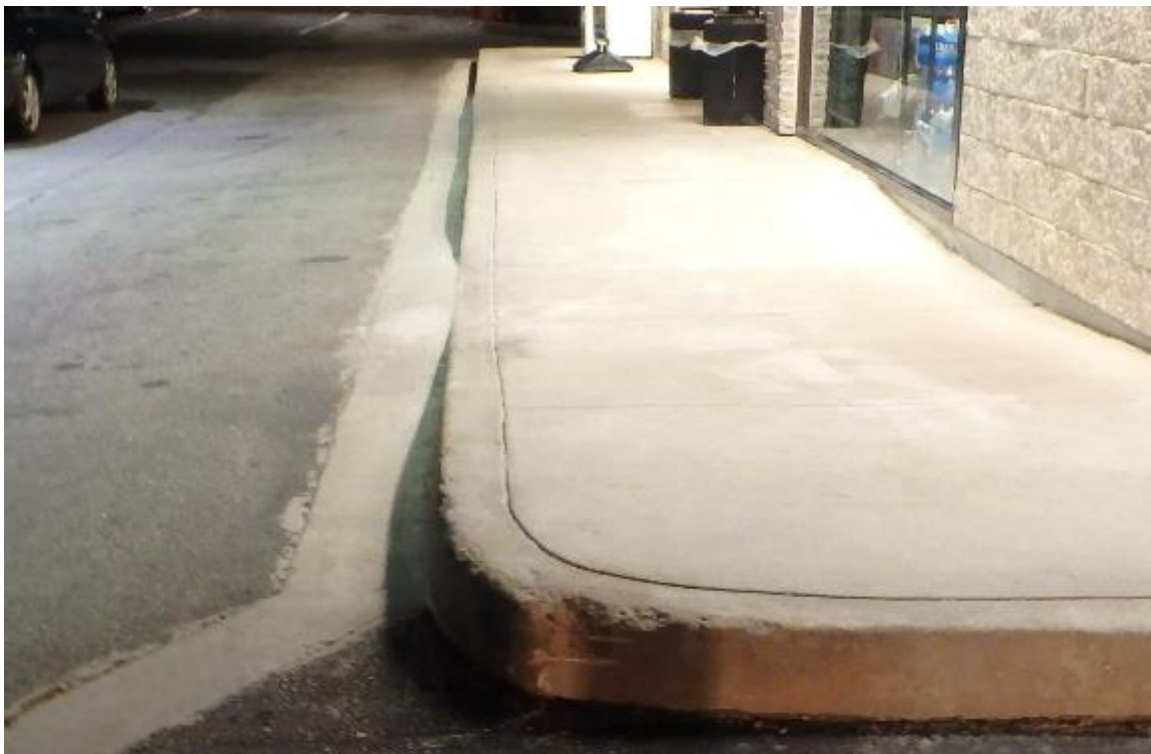
An enlarged view of the sidewalk and curb area revealed the 1 foot wide concrete area placed in front of and along the curb by Crompco in October 2015 (approximately 3 months prior to the incident), as shown in the photograph below.

The width of the sidewalk in front of the building measured 77-1/2 inches from the building wall to the back of curb, and approximately 83-1/2 inches to the face of curb. The color of the 1-foot strip in front of the curb and sidewalk was nearly identical to the top of curb and sidewalk abutting the store.

The height of the curb step measured approximately 7 inches.

As shown in the photograph above, an area of concrete in front of the curb had been installed and measured about 1 foot out from the face of curb.

Had Speedway, LLC applied black sealant over the approximately 1-foot wide concrete area along and in front of the curb, the curb/step condition would have been perceivable for Rod Sutton's direction of travel. Similarly, had the top of curb been painted "yellow," a contrast between the step condition of the curb would have been created and this incident could have been avoided.

The hazard of the camouflaged curb/sidewalk step condition in front of 258 South Easton Road should have been warned of by painting the curb “yellow” to avoid injuries to pedestrians, including Rod Sutton, or by applying black pavement seal coating to the 1-foot strip of concrete.

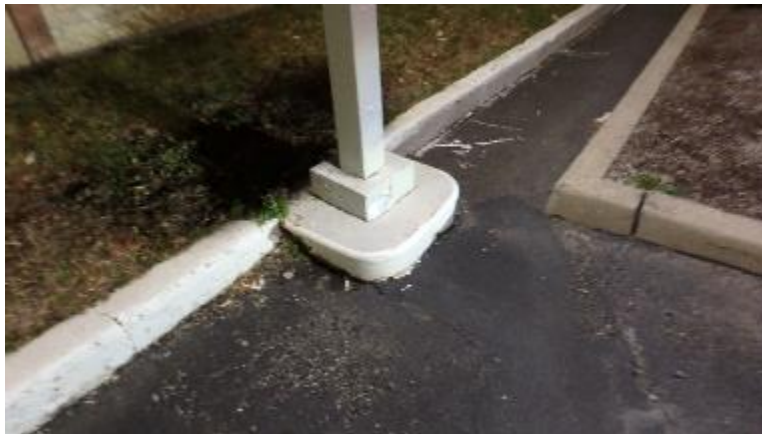
The perimeter curb was painted white along the north end of the parking lot, as shown in the photograph below.

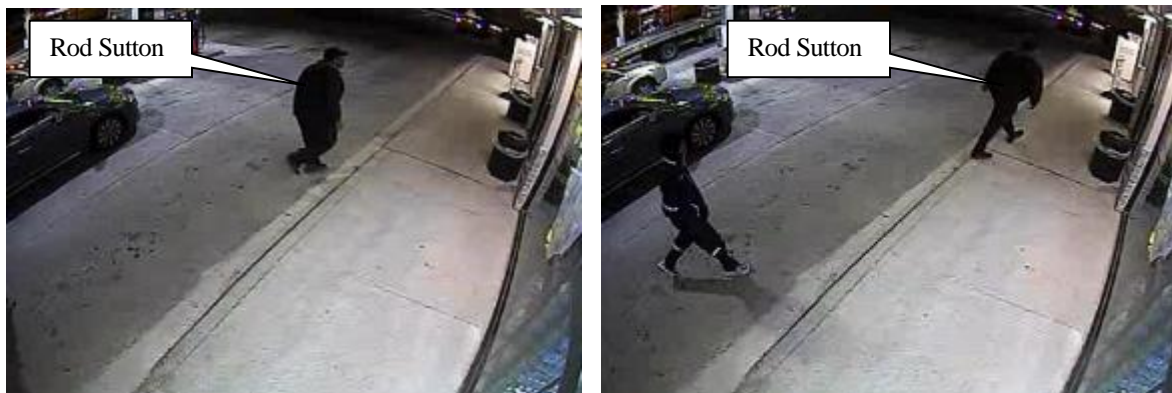
Surveillance video from January 19, 2016 was taken from various cameras throughout the store. One of the cameras was directed at the sidewalk area in front of the store. Shown in the screen grabs below is Rod Sutton walking towards the Speedway store to enter into the store and stepping up onto the sidewalk.

View of Rod Sutton walking from the parking lot towards the entrance of the Speedway store at 6:38 PM.

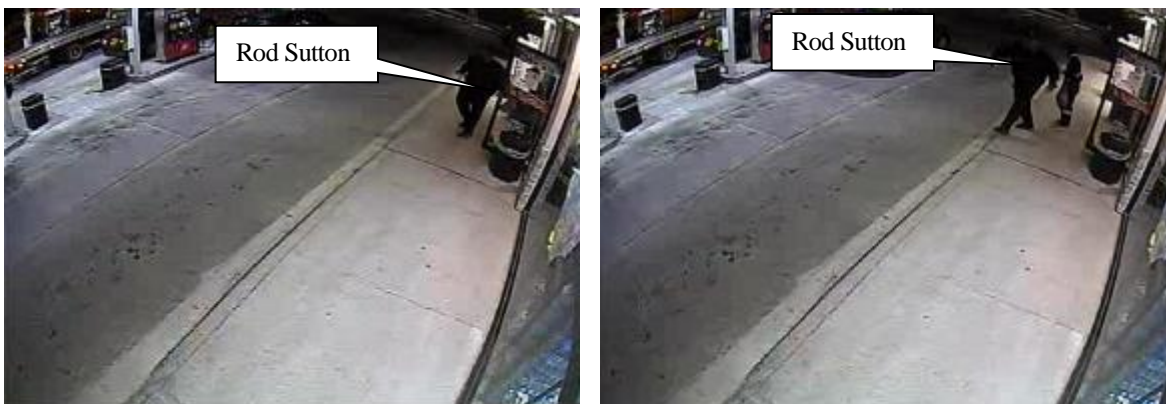
View of Rod Sutton walking from the Speedway store at 6:42 PM just prior to fall.

The video screen grab above shows the left foot of Rod Sutton partially overhanging the curb as he walks across the sidewalk.

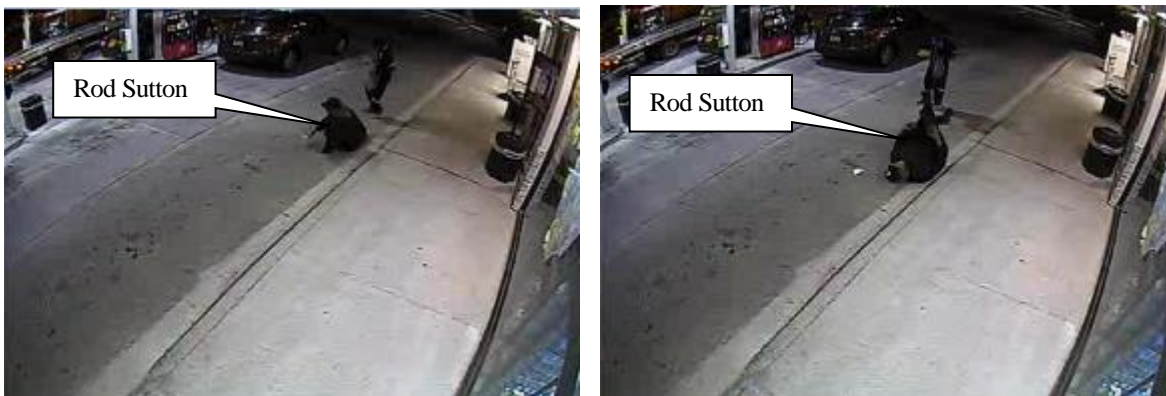
View of Rod Sutton having fallen to the parking lot from the sidewalk curb at 6:42 PM.

The camouflaged nature of the newly installed 1-foot strip of concrete against the concrete curb and sidewalk was also evident in the video.
